STATE OF COLORADO

DIVISION OF MINERALS AND GEOLOGY
Department of Natural Resources1313 Sherman St., Room 215
Denver, Colorado 80203
Phone: (303) 866-3567
FAX: (303) 832-8106

To: ANIMAS PROJECT MINE SITE TEAM**From:** Bruce Stover, *Bruce***Date:** February 5, 1996**DRAFT****Re: DRAFT GEOLOGIC SITE REPORTS**

LONGFELLOW-KOEHLER**Location**

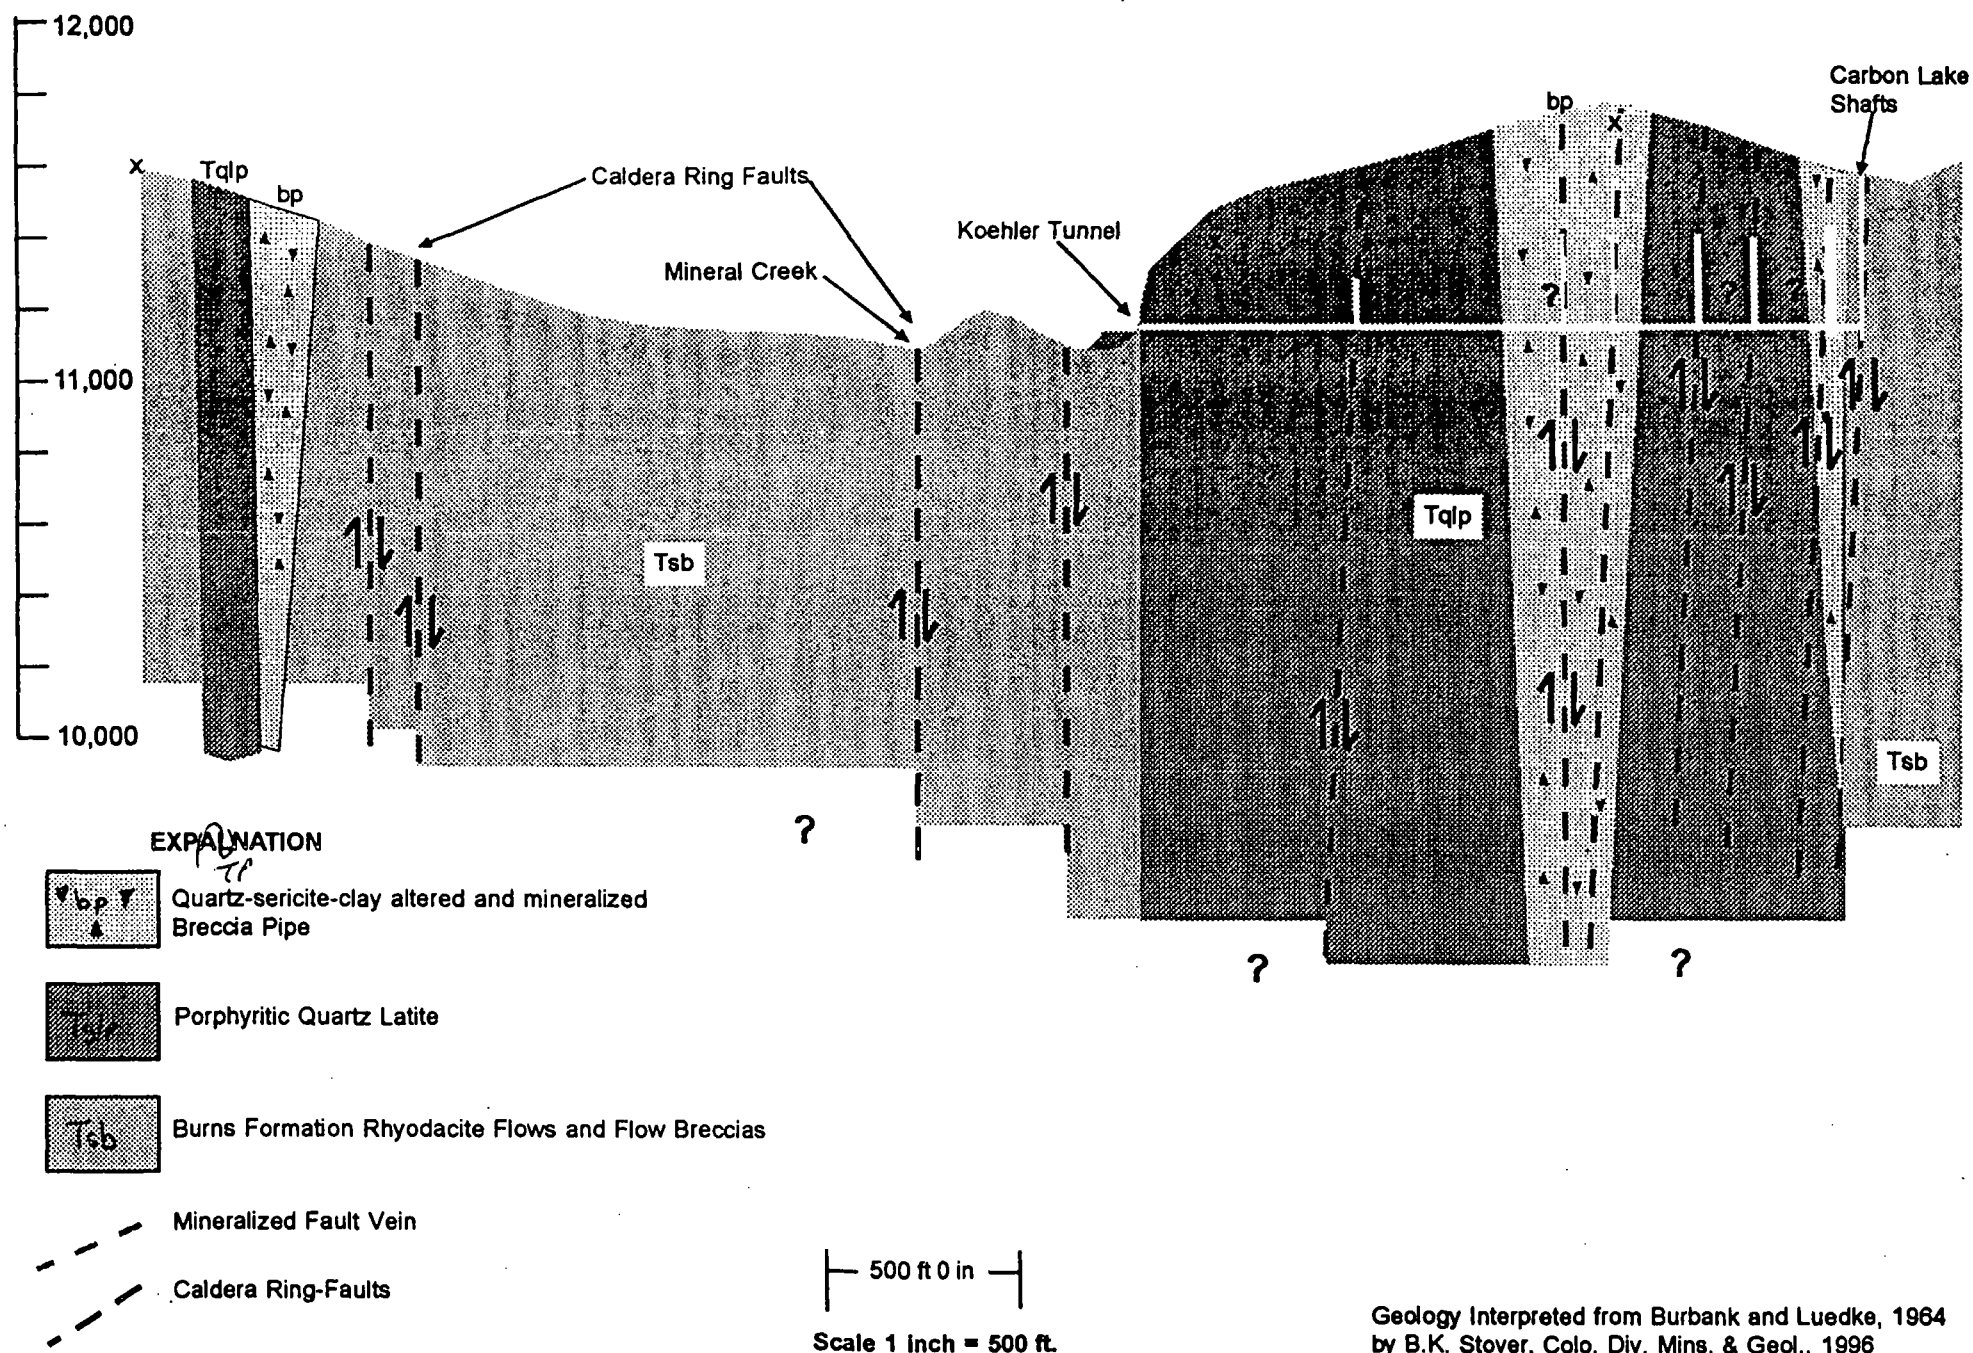
GEOLOGIC CROSS SECTION THROUGH LONGFELLOW-KOEHLER MINE SITE, RED MOUNTAIN PASS DISTRICT, COLORADO

The Longfellow-Koehler mine site is the most geologically complex in the Mineral Creek watershed. Its position at the faulted margin of the Silverton Caldera suggests a high potential for fracture-flow groundwater-minepool interactions which might complicate potential mine drainage remediation strategies. For example, if a treatment system is contemplated to address adit discharges, it will be necessary to determine any potential groundwater loadings which leave the site, and are not seen as surface flows at the portals. A treatment system could work well on the adit discharge, but fail to meet metals removal goals in the stream due to un-identified groundwater loading sources.

Collection of the water flows from the adits for treatment could also be problematic. The fractured, jointed nature of the bedrock could be allowing seepage from the adits to enter the groundwater systems, as suggested by the numerous springs at the base of the porphyry plug. Simply sticking pipes into the portals may not suffice to collect all the water which needs to be treated. It may be necessary to re-enter the adits to some point beyond fracture influences where a grout-sealed bulkhead water-inlet can be placed to collect and prevent infiltration of tunnel flows into fractured bedrock.
